Indian Institute of Technology Madras Office of International & Alumni Relations

University Rover Challenge 2017 – Report

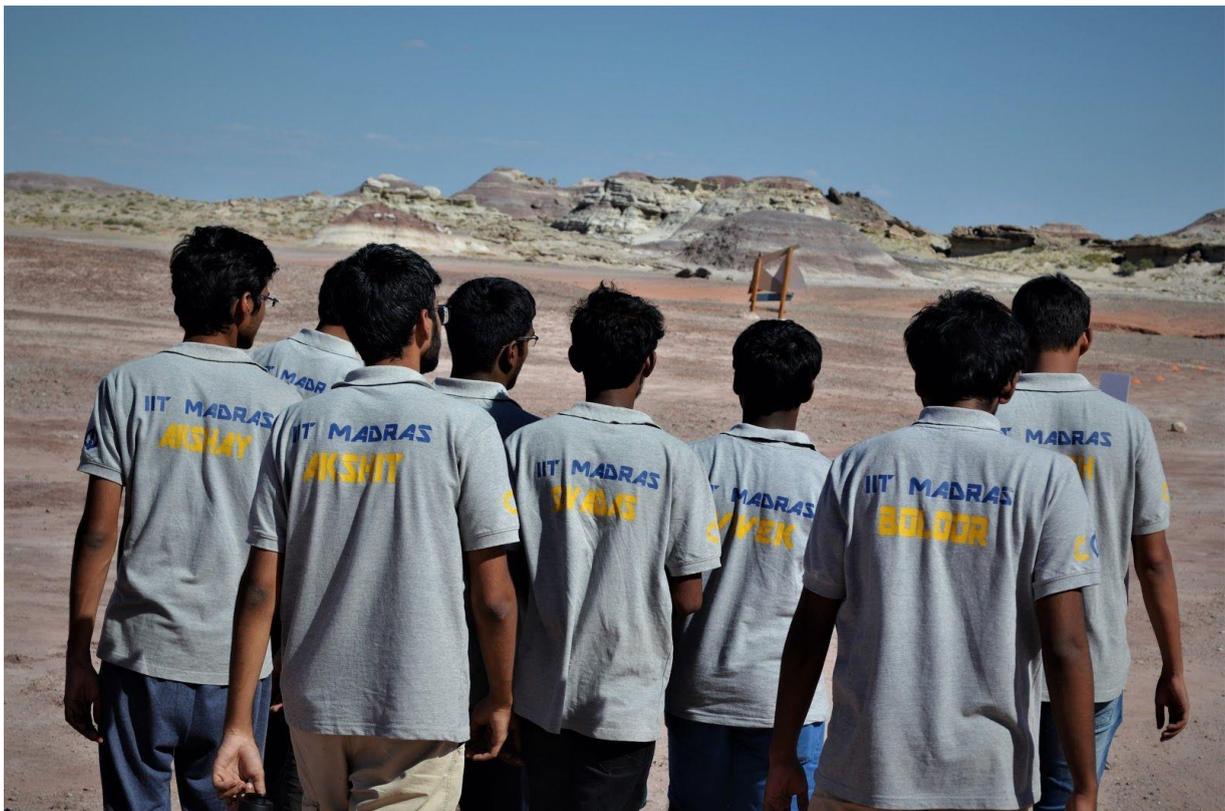
The task was scheduled to begin at 8:10 AM. We reached MDRS at 7:30 AM and started setting up. The rover was weighed to be 52.6 kgs without batteries for which a 10% penalty was awarded. The task setup time eventually began at 8:30 AM. Once again, we weren't able to run the locomotion through the routers and antenna. After trying for about 45 mins, the locomotion started working and we started the task. At that point, we had only 5-10 mins of task time remaining. Moving towards the first checkpoint, the rover wheels got stuck in sand. When trying to move it with a zero radius turn, the bogie joint inverted and the task was stopped. We weren't able to score any points in this task.

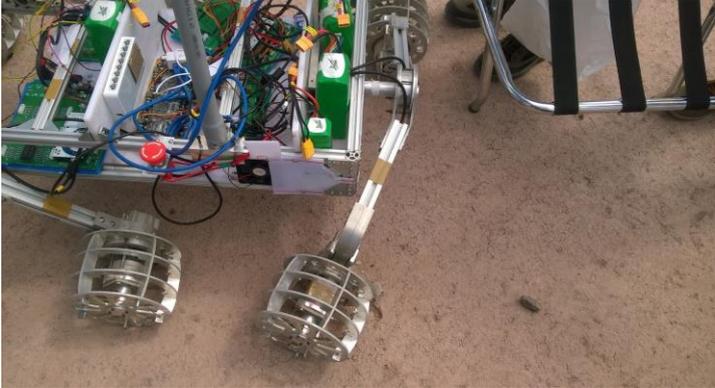
Mechanical	Identified	Fixed
<p><u>Bending of Aluminum plates</u> Noticed on: 1 June 2017</p>

<p>The articulation joint plates got bent while doing zero radius rotation.</p> <p>Steps for fixing the issue:</p> <ol style="list-style-type: none"> 1. After removing the plates, hammer them to make them flat. 2. Make a through hole through the T-slot and use a 6mm bolt instead of T-bolt. This ensures a rigid joint which won't let the aluminium plate to slip on the T-slot. 	<p>Yes [1/6]</p>	<p>Yes [1/6]</p>
<p><u>Flipping of Bogie Joint</u> Noticed on: 2 June 2017</p> <p>The bogie joint underwent complete rotation while trying to do zero radius rotation. The problem was faced because the wheels got stuck in the soil as they were trying to dig the soil when the rover was driven at slow speed.</p> <p>Steps for fixing the issue:</p> <ol style="list-style-type: none"> 1. Not yet rectified. 	<p>No</p>	<p>No</p>
